E.ON – POWER STATION - BELGIUM

Steel structures coated with ZINGA

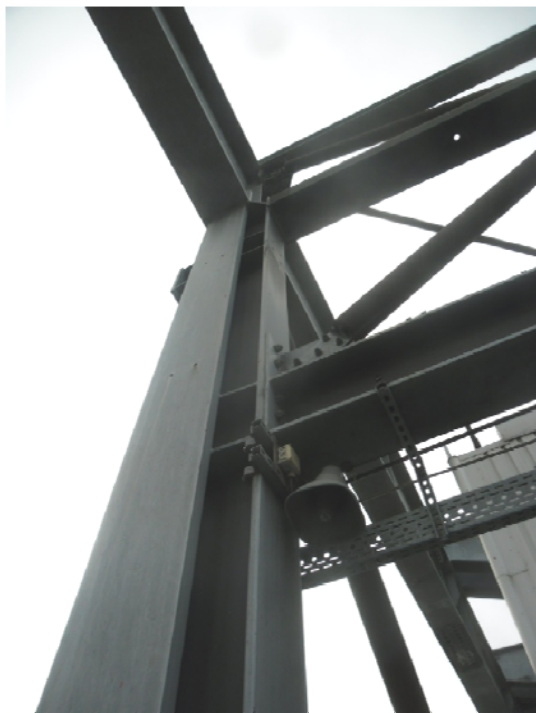
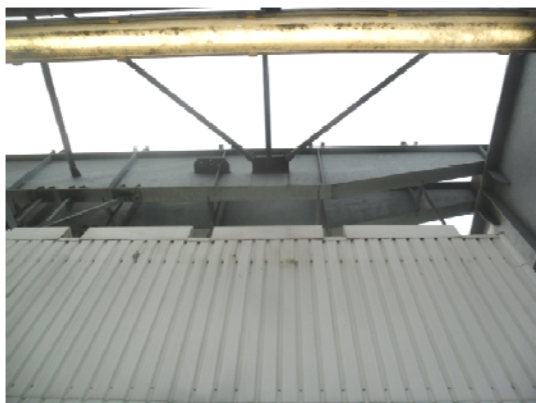
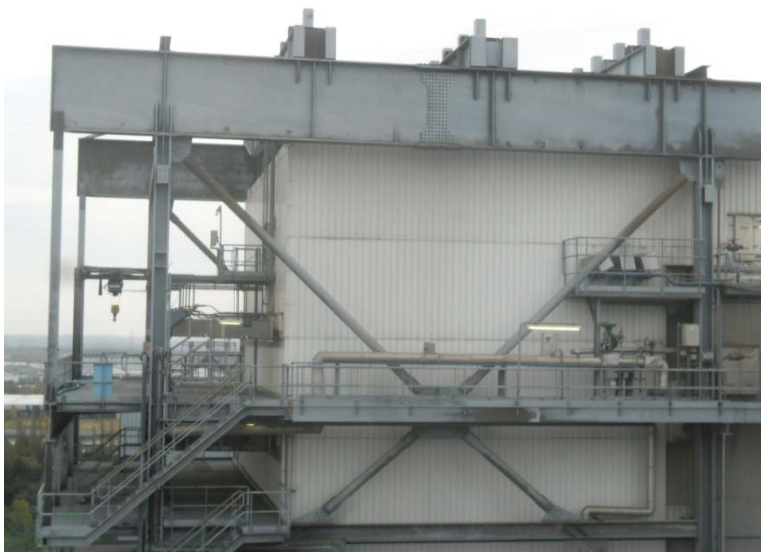
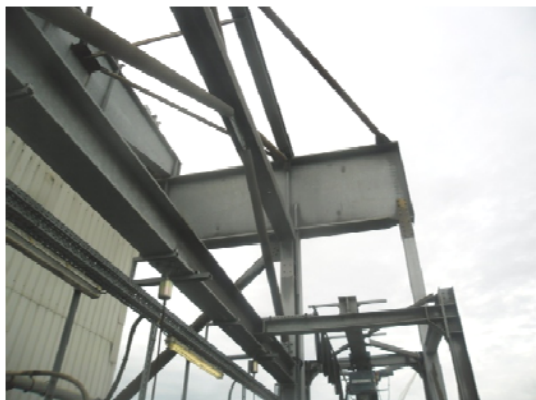
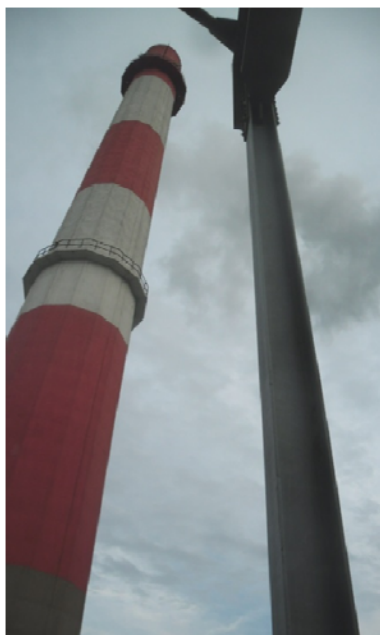
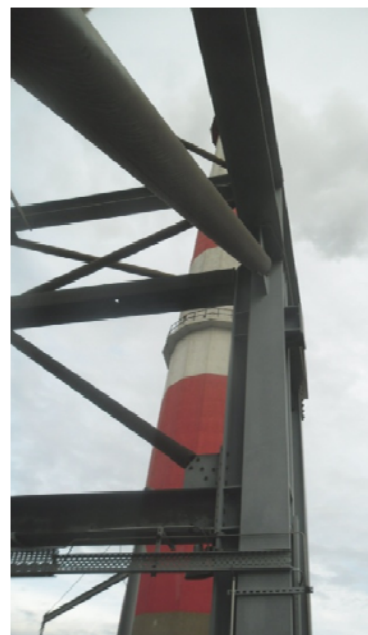
Condition in 2014

The beams were treated with 2 x 60 µm DFT after steel fabrication at Victor Buyck to provide a good corrosion protection in a harsh industrial environment.

An inspection in 2014 found the beams in good condition showing no signs of corrosion and with a Zinc depletion of only 20 µm DFT.
