E.ON – POWER STATION - BELGIUM

Steel structures coated with ZINGA

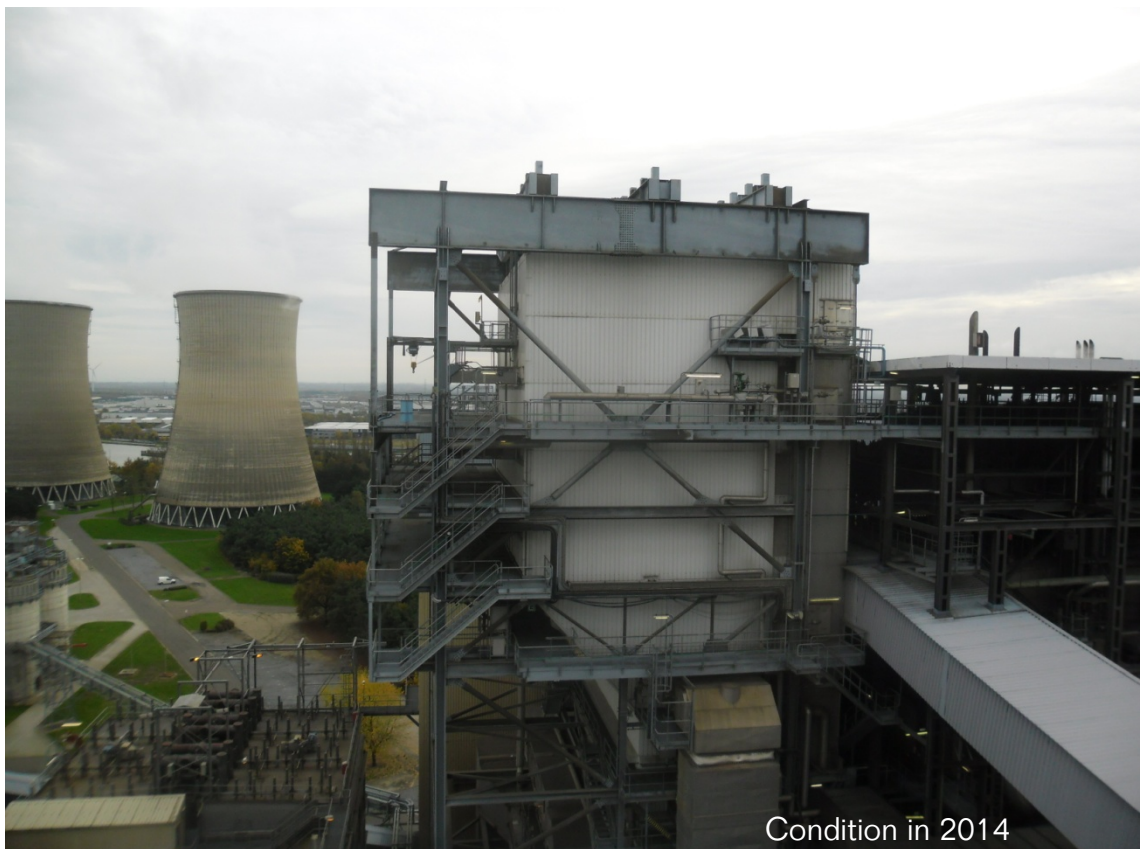
Condition in 2014

An inspection in 2014 found the beams in good condition showing no signs of corrosion and with a Zinc depletion of only 20 µm DFT.
